FLOOD INUNDATION DUE TO ASSUMED BREACHING OF ATTABAD LANDSLIDE DAM, PAKISTAN

Authors: Arham Mansoor, Noor Muhammad Khan, Aziz Akbar,
Yasir Abbas, Muhammad Umar Farooq

Affiliation: Department of Civil Engineering, University of
Engineering and Technology Lahore, Pakistan

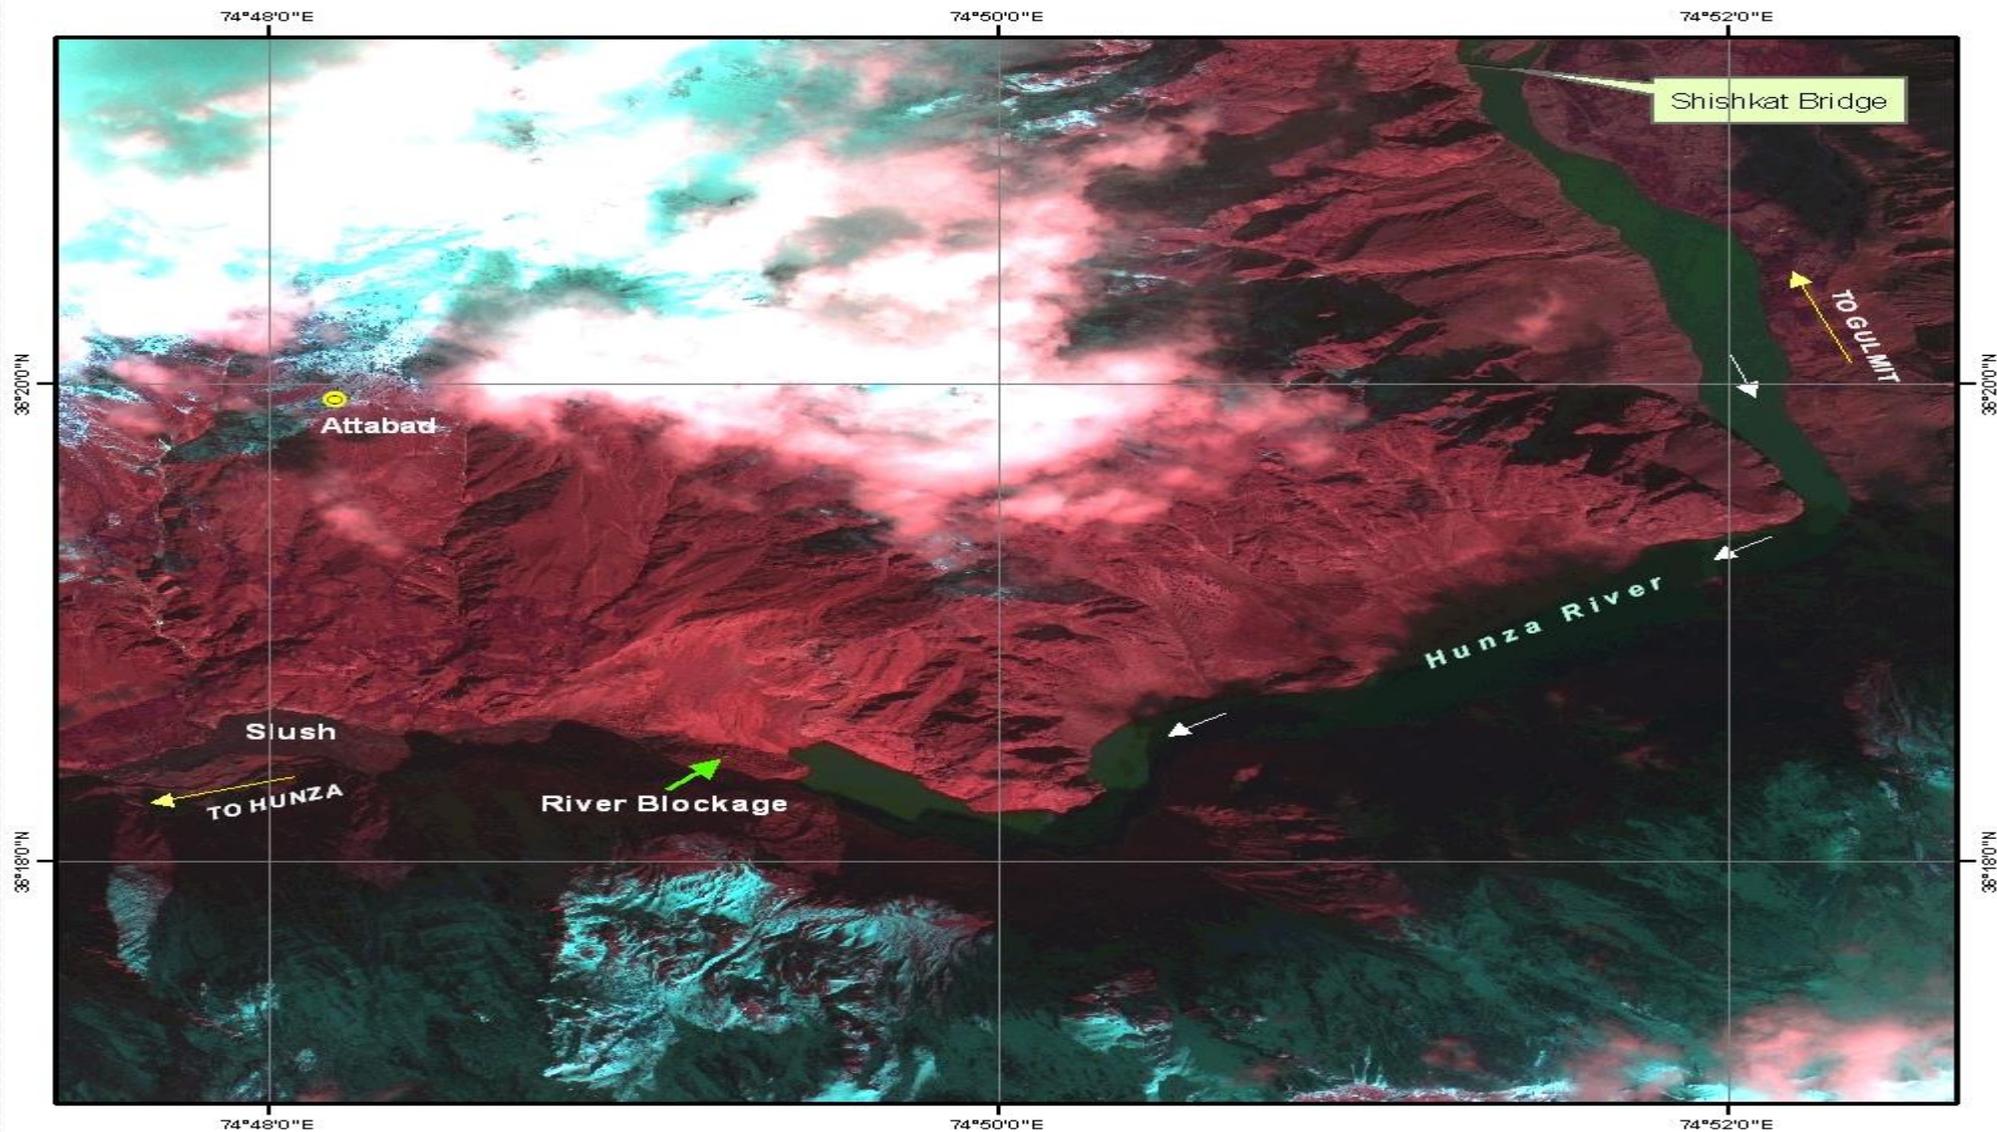
SATELLITE IMAGERY OF THE LANDSLIDE AREA

- A massive landslide occurred in Hunza river basin on January 04, 2010 near Attabad village, about 100 km upstream of the confluence of Hunza and Gilgit rivers.
- Due to this landslide, a natural dam of **126 m to 210 m** height has been created across Hunza River.
- Width of dam crest is approximated as **350 m** whereas its length along the river is **2 km**.
- Due to the blockage, created by the landslide, the water of the Hunza River started accumulating as a lake, upstream of the so formed land slide dam.
- The length of reservoir was reported as **15.5 km** on 7th May 2010.
- **305 MCM** is volume of the water that could be stored in the lake up to the top of the landslide.

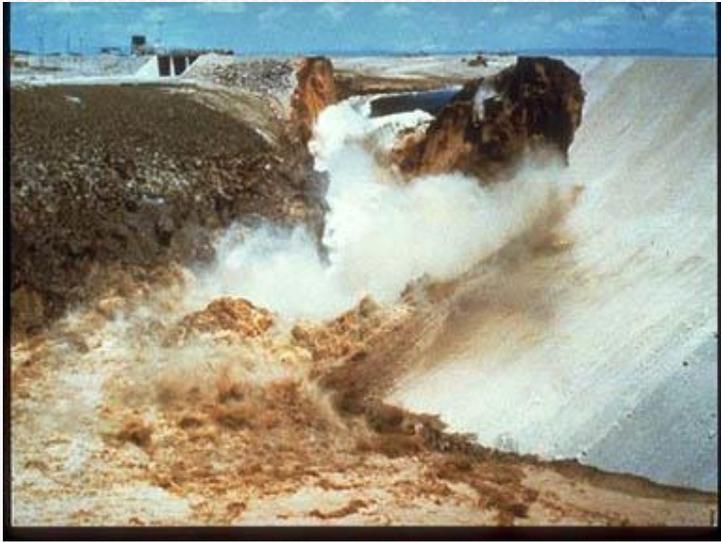
Avalon Dam,
United States

DAM BREACH – TRIGGERED DUE TO PIPING

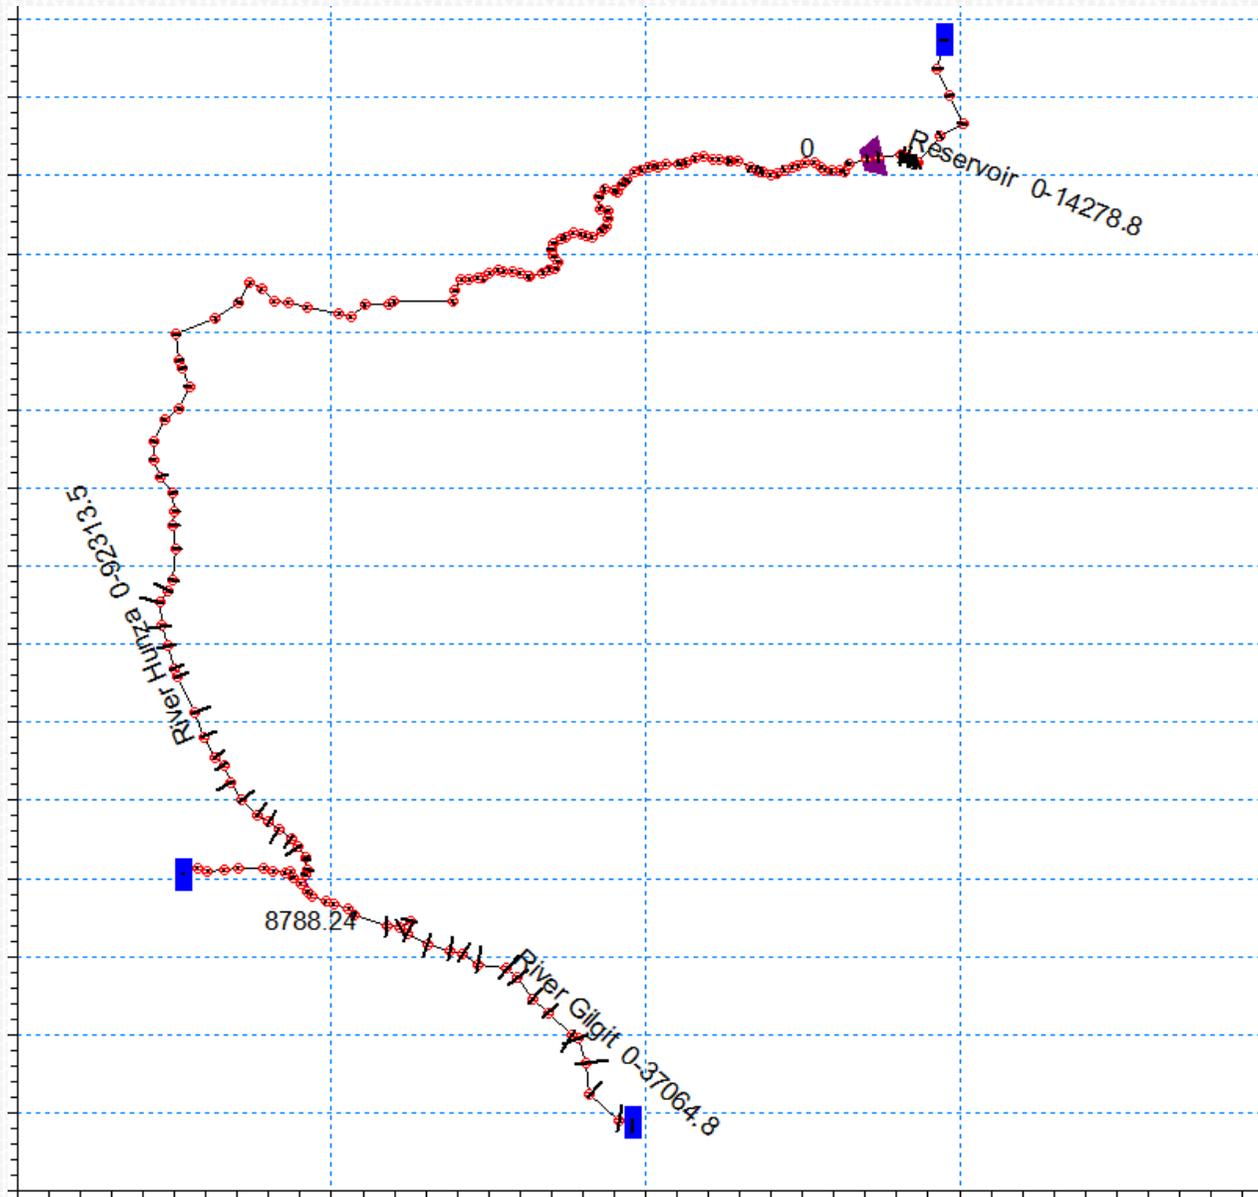
RIVER NETWORK

- Boundary Points
- Landslide Mass
- Cross sections

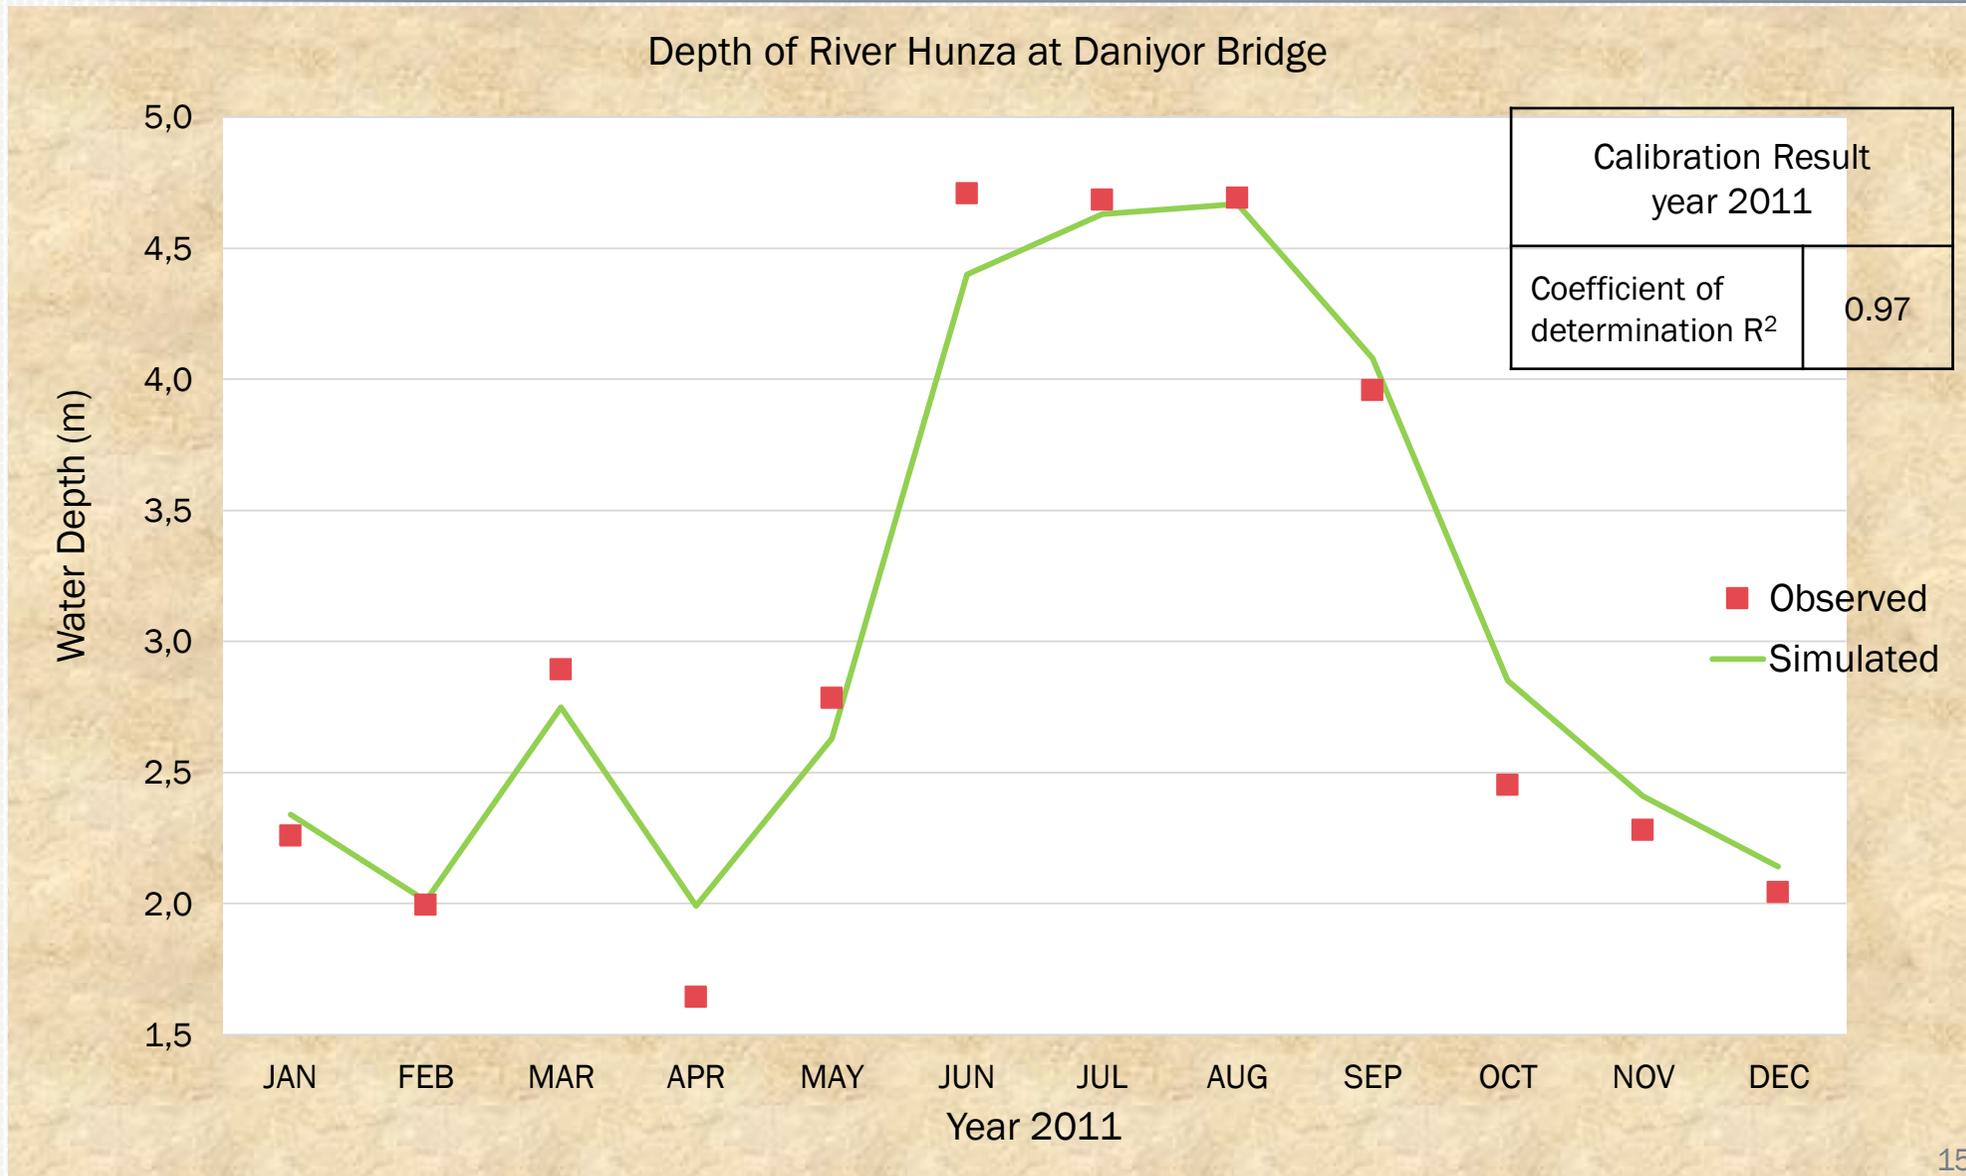
CALIBRATION RESULT

- CALIBRATION
 - U/S boundary: Inflow Hydrograph of River Hunza (2011)
 - D/S boundary: Rating curve at Alam Bridge (River Gilgit)
- VALIDATION
 - U/S boundary: Inflow Hydrograph of River Hunza (2012)
 - D/S boundary: Rating curve at Alam Bridge (River Gilgit)
- Manning's roughness coefficient 0.03 is taken (Chow, V.T.1966) which depicts that the channel is very much rough having boulders and rocks in it.

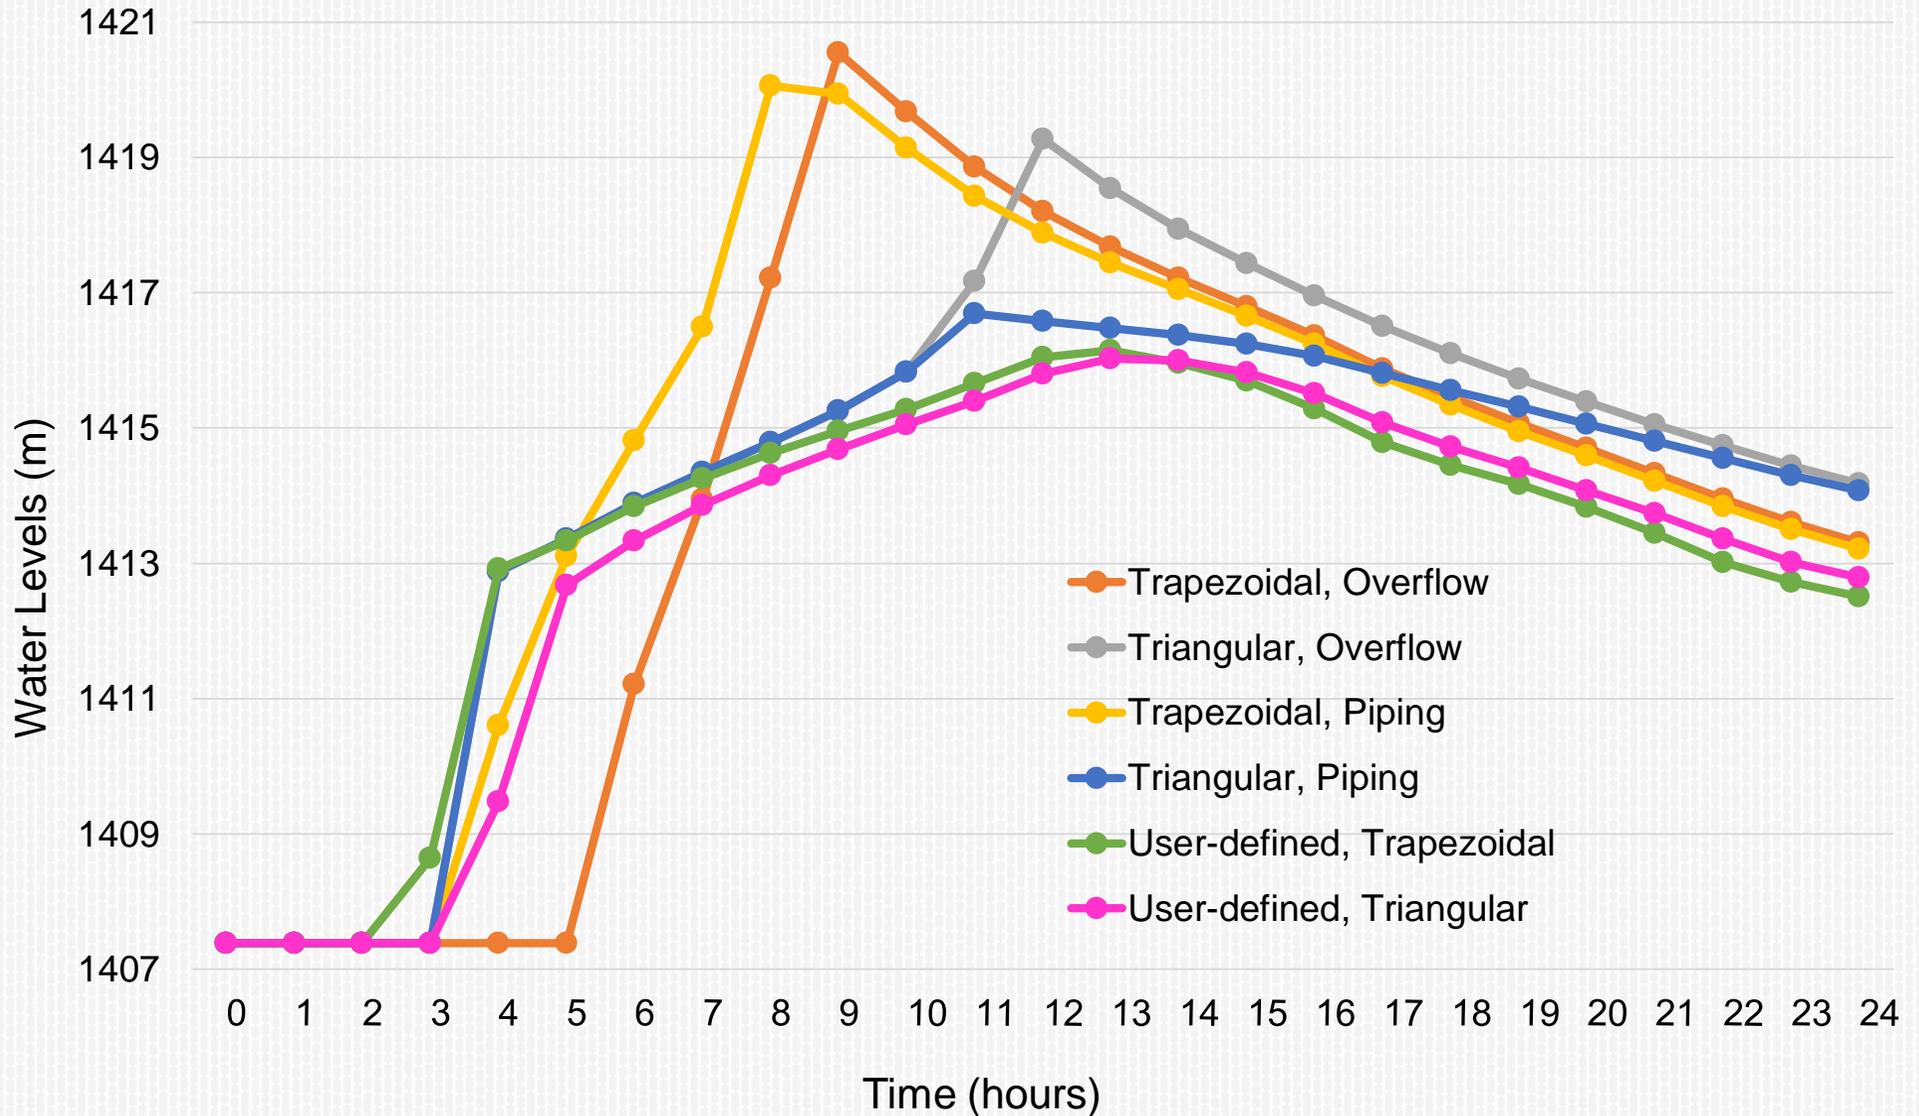
COMPARISON OF PEAK WATER LEVEL B/W DIFFERENT DAM-BREAK CASES

Breach Growth	Triggering	Shape of Breach	Peak Water Level at Daniyor Bridge (m, amsl)	Water Depth at Daniyor Bridge (m)	Time to peak (hrs)
Erosion	Piping	Trapezoidal	1420.06	12.67	8.0
		Triangular	1416.69	9.30	11.0
	Over-topping	Trapezoidal	1420.55	13.16	9.0
		Triangular	1419.27	11.88	12.0
User-specified		Trapezoidal	1416.15	8.76	13.0
		Triangular	1416.03	8.64	13.0

- Erosion based trapezoidal breach due to overtopping of the landslide mass is the 'worst case scenario' causing maximum flood peak of 11,545 cumec to occur at Daniyor Bridge and the depth of water to be 13m.
- Peak flow reaching Daniyor Bridge due to trapezoidal breach = 2.3 times the historic maximum flood whereas, for triangular breach it is 1.5 times the flood magnitude (i.e. 5000 cumec) which Daniyor has faced in 1967.

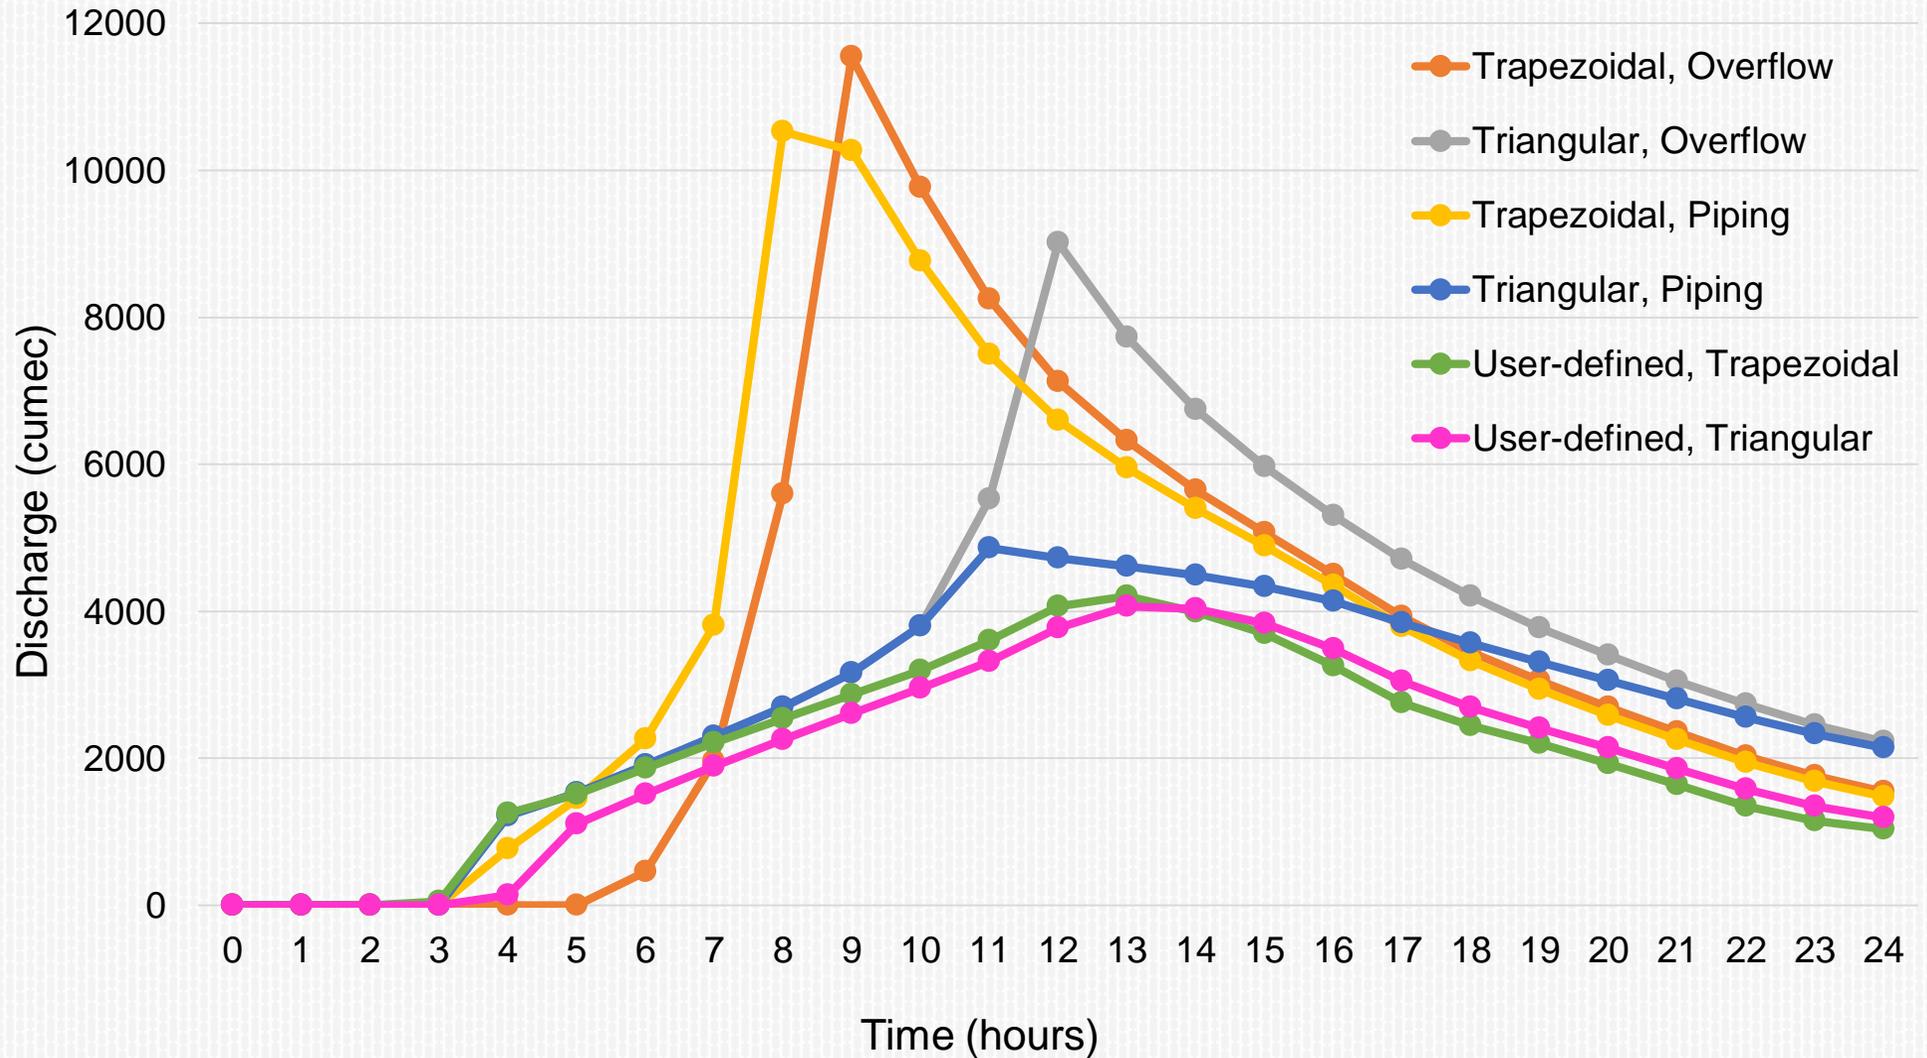
COMPARISON OF DISCHARGE B/W DIFFERENT DAM-BREAK CASES

Breach Growth	Triggering	Shape of Breach	Discharge at Daniyor Bridge (cumec)	Time to peak (hrs)
Erosion	Piping	Trapezoidal	10,528	8.0
		Triangular	4,862	11.0
	Over-topping	Trapezoidal	11,545	9.0
		Triangular	9,017	12.0
User-specified		Trapezoidal	4,205	13.0
		Triangular	4,069	13.0

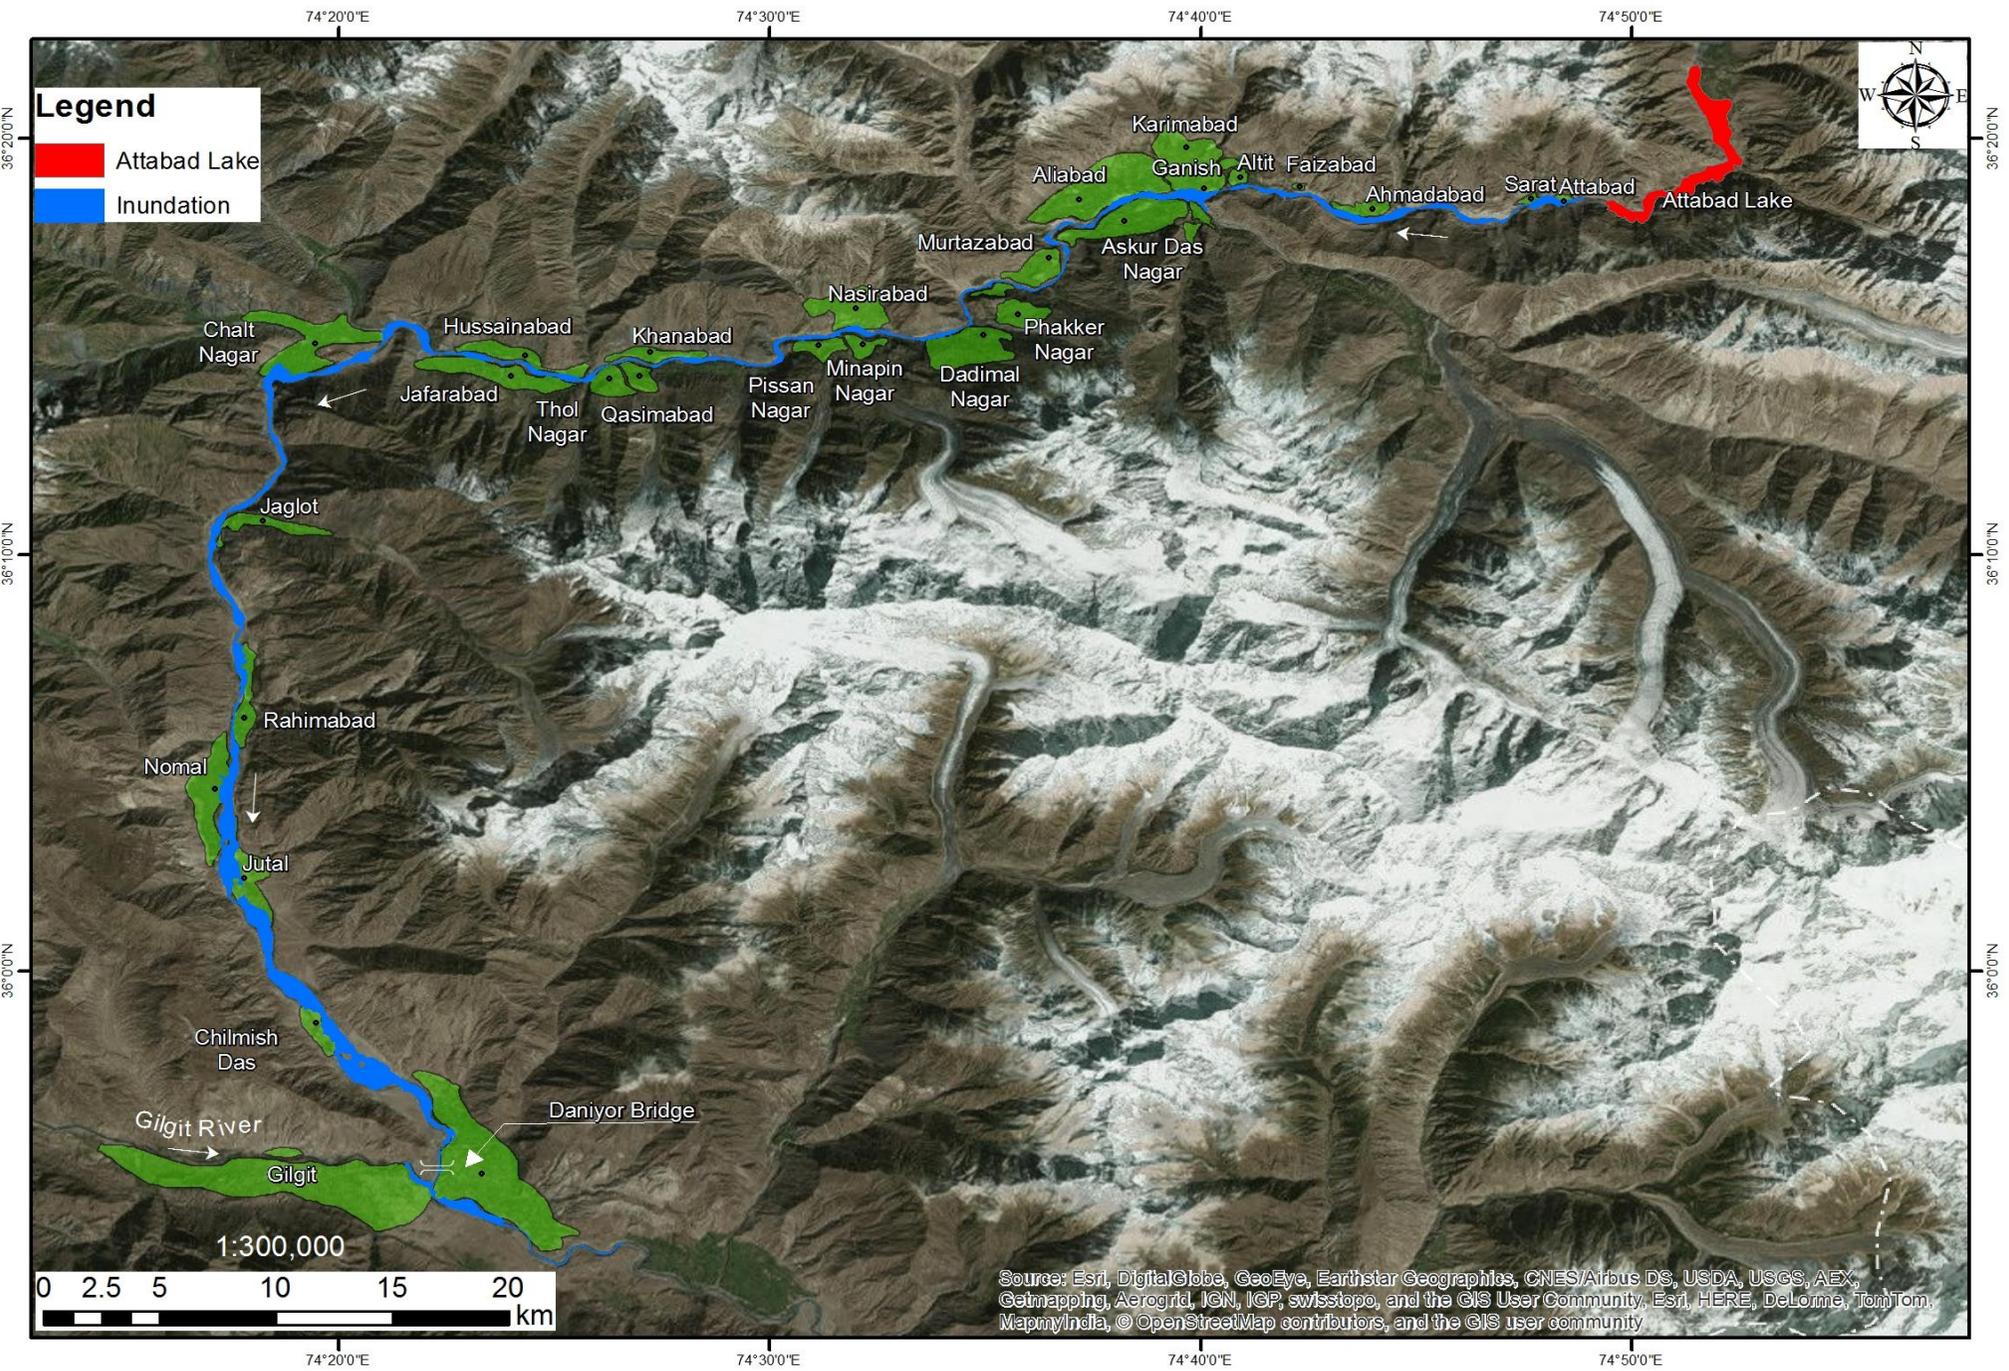
- Routing of the resulting flood wave has been animated
- Flood Inundation map

- █ Attabad Lake
- █ Inundation
