Habitat structure changes of the Wisłoka river as a result of channel restoration

Leszek Książek, Agnieszka Woś, Maciej Wyrębek, Andrzej Strużyński

International School of Hydraulics

21 - 24 May 2019 • Łąck • Poland

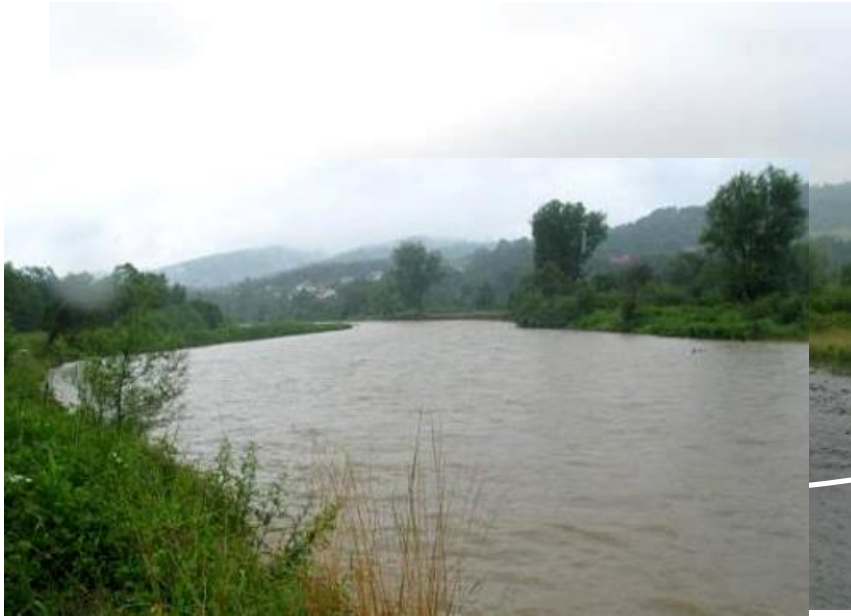
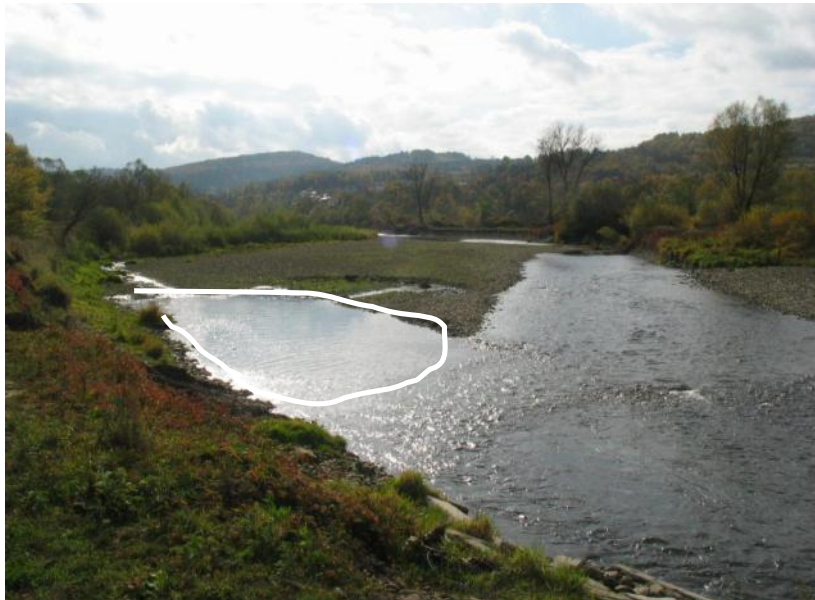
Mezohabitats

Habitats – the living space of the water organisi, the zone on the river bed characterise by relatively constant flow parameters
Mezo – scale/dimension

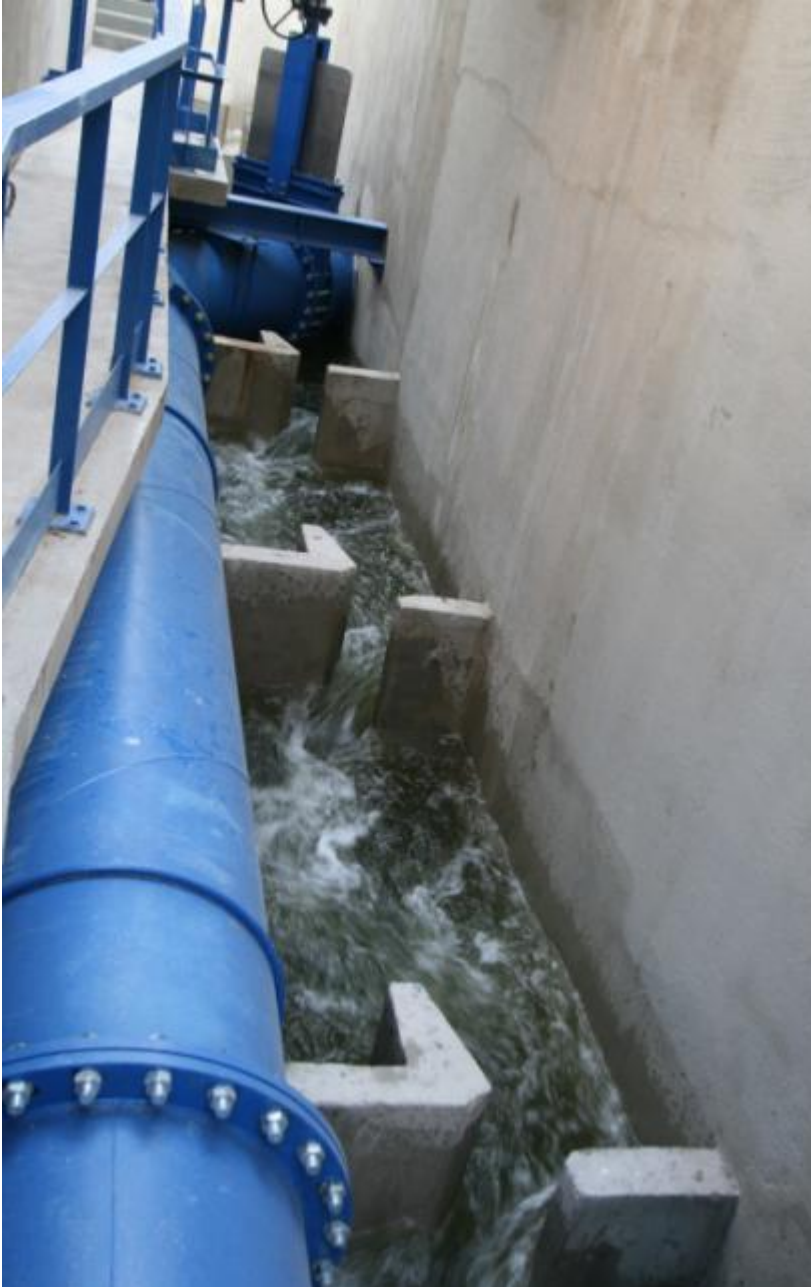
Reconstruction of fish ladder – Włocławek Reservoir 2014

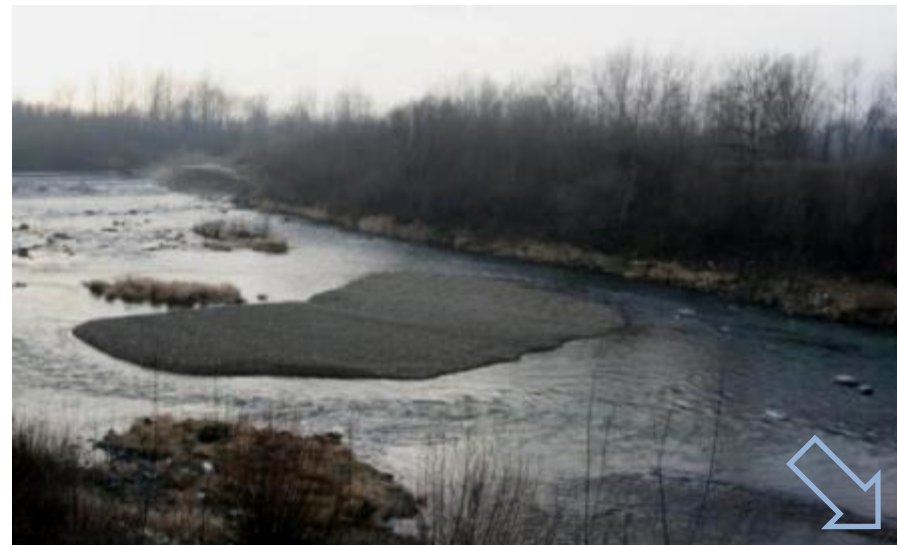
Deposition of bed material

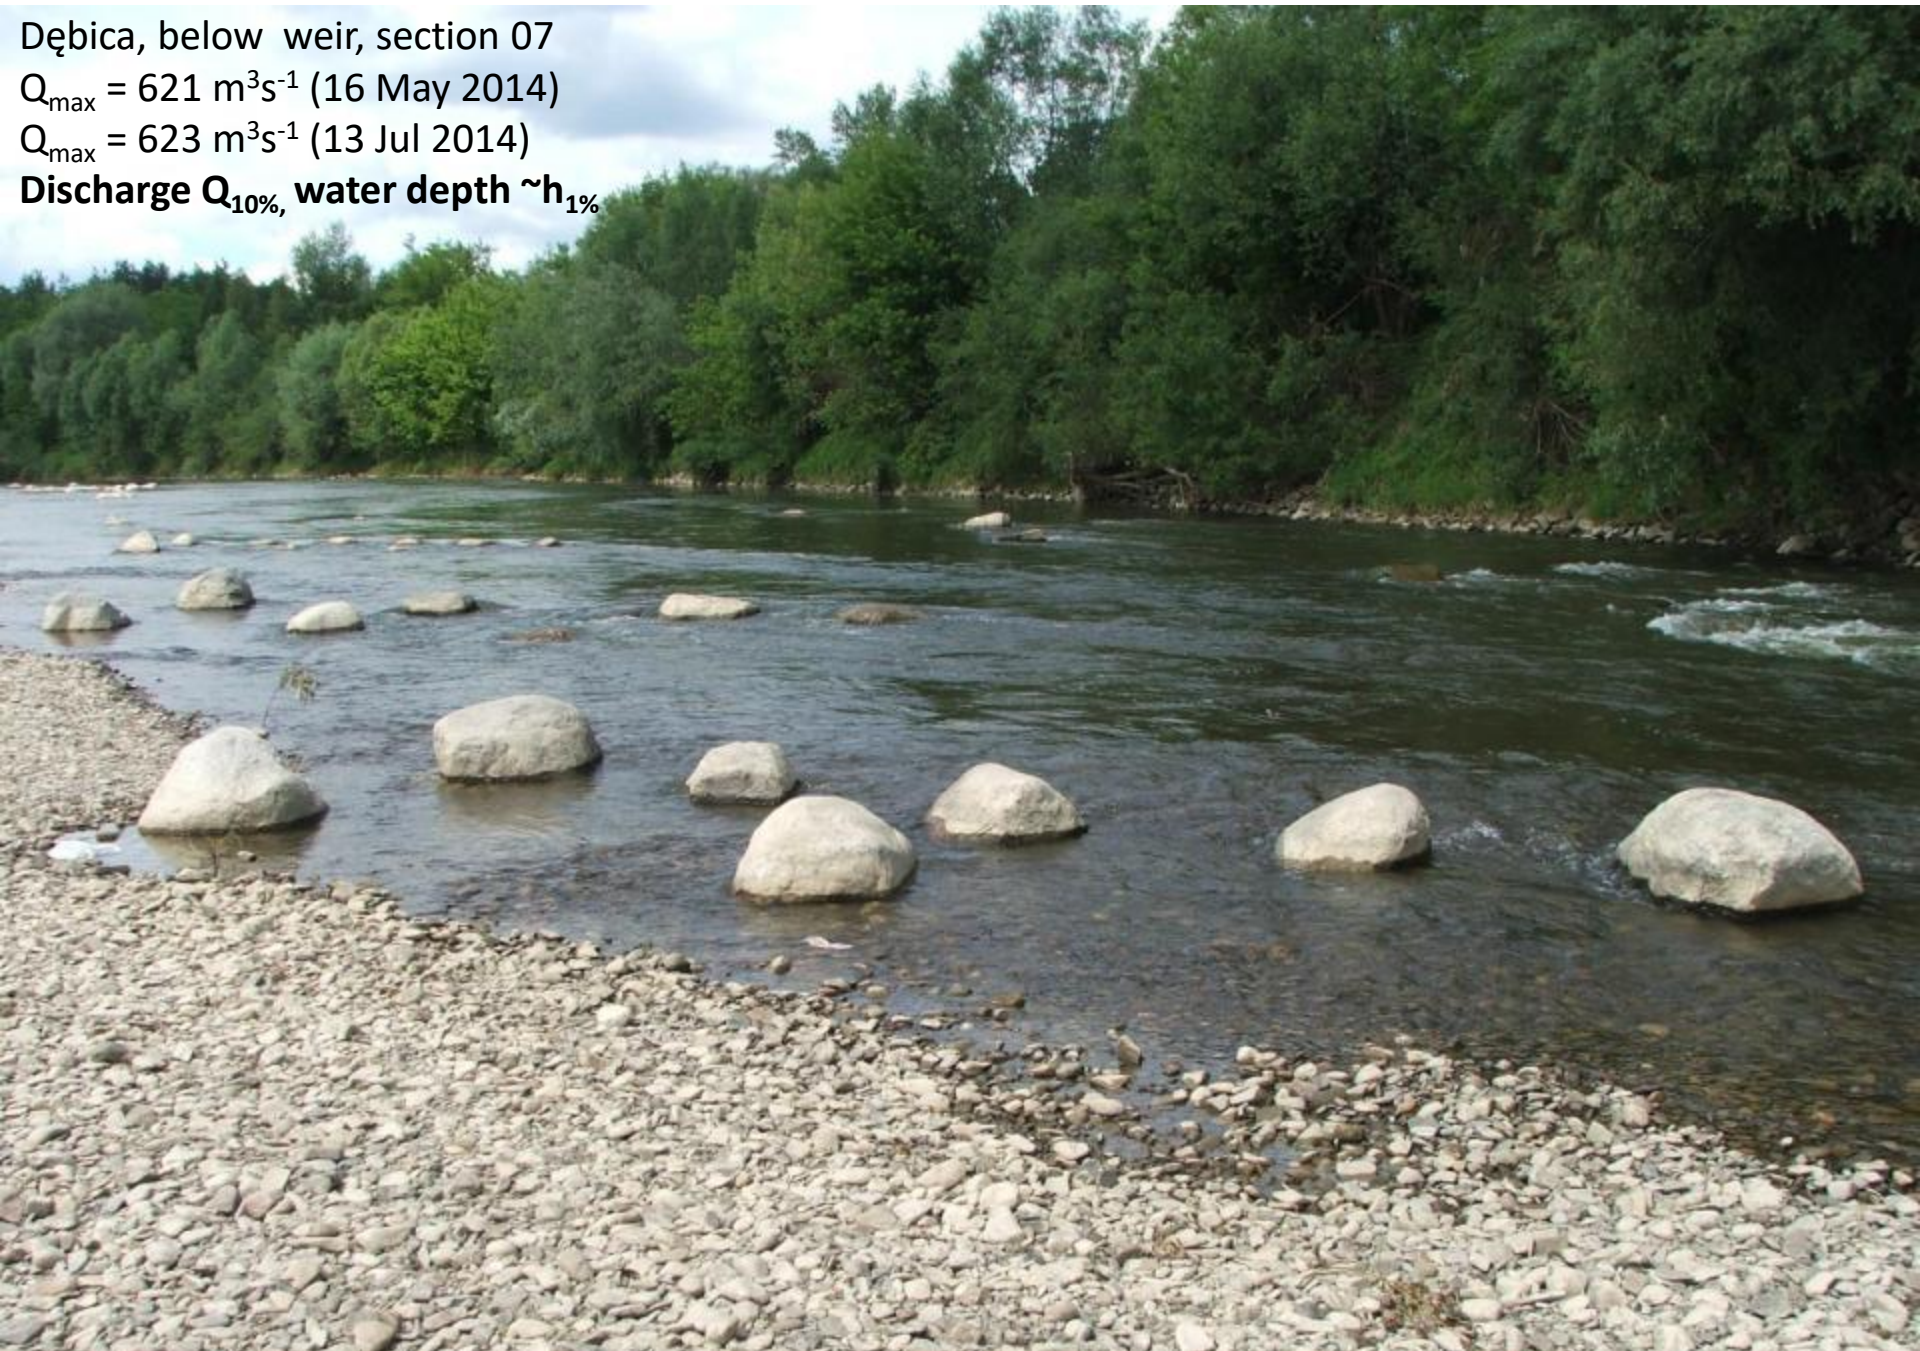
Dębica, below weir, section 07
 $Q_{\max} = 621 \text{ m}^3\text{s}^{-1}$ (16 May 2014)
 $Q_{\max} = 623 \text{ m}^3\text{s}^{-1}$ (13 Jul 2014)
Discharge $Q_{10\%}$, water depth $\sim h_{1\%}$

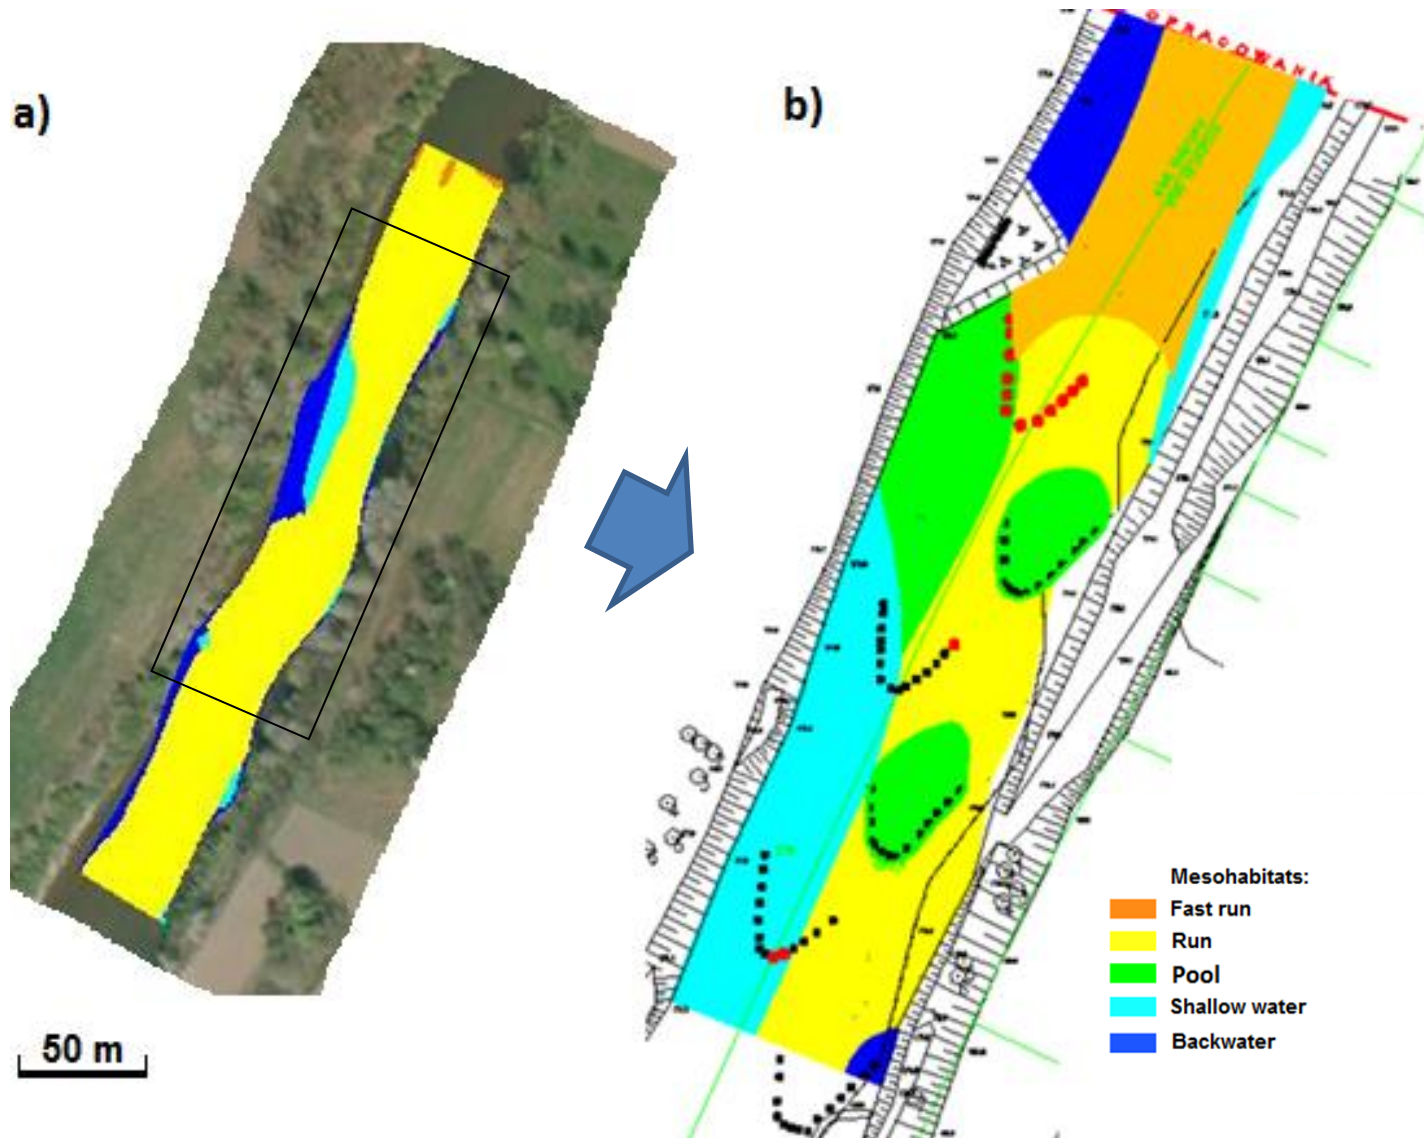
Conversion of a homogeneous flow (riverbed) into a rich mosaic of habitats

Before (Q_{dec}):
riffie – 0.2%,
fast run – 7.4%,
run – 55.6%, shallow
water – 25.0%,
backwater – 11.9%,
pool – 0%.

After (Q_{pom}):
riffie – 0.8%,
fast run – 18.1%,
run – 33.2%,
pool – 23.5%, shallow
water – 13.9%,
backwater – 10.5%.

Low energy habitats
(shallow water and
backwater) from 36.9%
to 24.4% - decrease,
fast flow from 9.6% to
18.9% - increase
medium energy (pool) -
increase

- after restoration, all types are represented in the habitat structure. There is a noticeable decrease in the contribution of low energy habitats, the appearance of areas with medium energy and increase in areas with high energy habitats.
- channel restoration activities improved the morphological quality of the channel but did not cause a significant change of the all river valley - in seven locations increased their channel grade by one class.

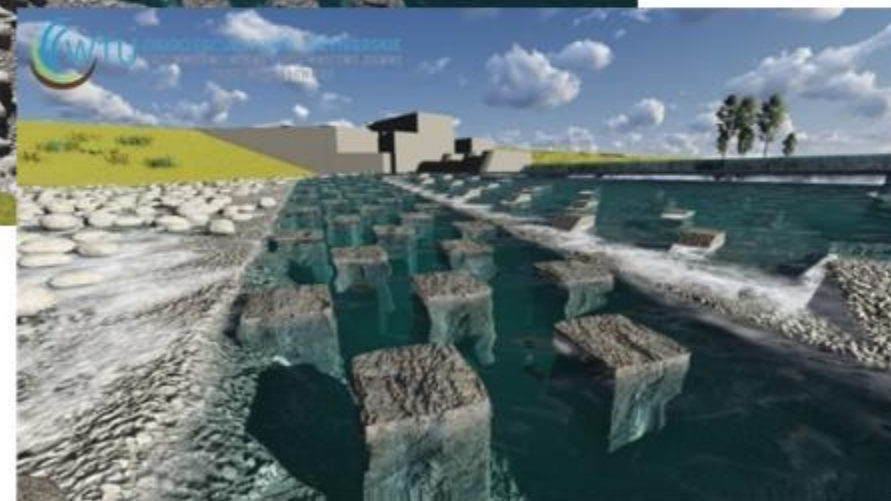
Fishway project
Dębica, Wisłoka River km 56+180
